Investigating Structural Cracks for Infrastructure: Case Study of Anonymous Hospital, in Zimbabwe

Faculty of Engineering, University of Zimbabwe, P.O Box MP167 Mount Pleasant, Harare, Zimbabwe

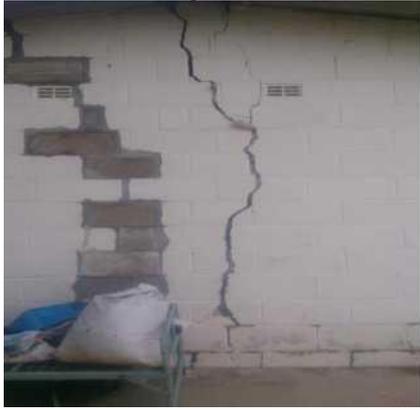
Fig. 2. A jagged vertical crack on the wall of a building

The vertical wall varied from 1 m to 5 m in length and 0.5 mm to 45 mm in width. Externally applied loads cause horizontal cracks. Settlement problems and heaving cause vertical cracks which are wider at the top and bottom. Table 1 shows the results obtained during fieldwork at the anonymous Hospital. The design limits according to BS5628 [16].

The crack widths exceeded the design limits so these are structural cracks which need to be repaired urgently, from [17] these are more than 25 mm. Geotechnical and analytical approaches were employed in the collection of the data.

From [19] for cracks up to 1 mm the damage is only experienced to the wall finishes and the treatment can be done by normal decoration. Cracks with a width from 1 to 5mm can easily be filled. Cracks from 5-15 mm require some opening up and can be patched by a mason, some bricks need to be replaced. For cracks from 15-25 mm this is extensive damage and requires breaking out and replacing sections of the wall especially over doors and windows. The walls will be leaning or bulging. For cracks more than 25 mm this is structural damage that requires a major repair job involving partial or complete rebuilding. If cracking on concrete is due to drying shrinkage the crack will stabilize, if due to foundation settlement the settlement problem must be corrected [9]. For cracks less than 1 mm bonding by injection of epoxy is recommended. Routing and sealing of cracks can be used whereby the crack is enlarged along its exposed face and a joint sealer is used to fill and seal the crack [9]. The other methods recommended include near-surface reinforcing and pinning, additional reinforcement, drilling and plugging, polymer impregnation, grouting and crack arrest [9].

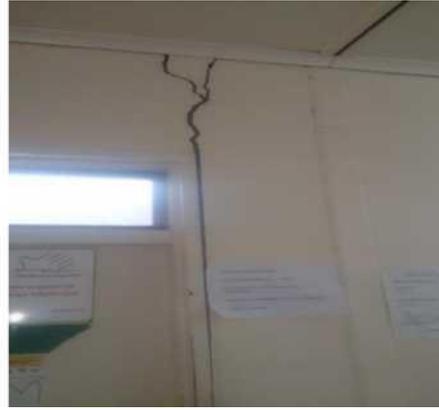
Fig. 3. Vertical crack on another building

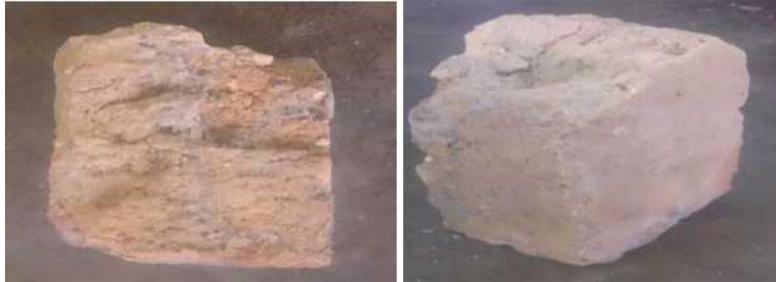
Fig. 6. Common Farm Brick collected from site shows weak bearing capacity and would crumble easily.

- The bricks utilised for the construction are of poor flexural strength and the brickwork was not bonded creating fault line vertical cracks
- The soils are sodic in nature and resulted in collapse as the sodium component dissolved with fresh water and subsequent erosion below foundations.
- The Mine company blast could not be directly sidelined though vibrations can be the reason for the increased crack width and effect of topography on foundation erosion.
- The bearing capacity of the soils in some cases was not adequate to carry the load.
