Effects of Plasma Cutting on Surface Integrity of Mild Steel

Abstract:

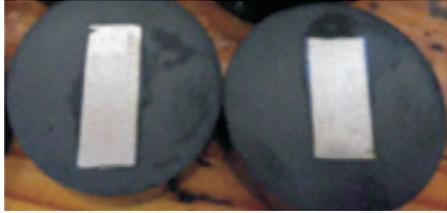
Figure 4: Mounted test pieces.

further etched for 18 seconds using Nital, a solution composed of 100 ml ethanol and 100 ml of nitric acid. Prepared and mounted test pieces are shown in Figure 4.

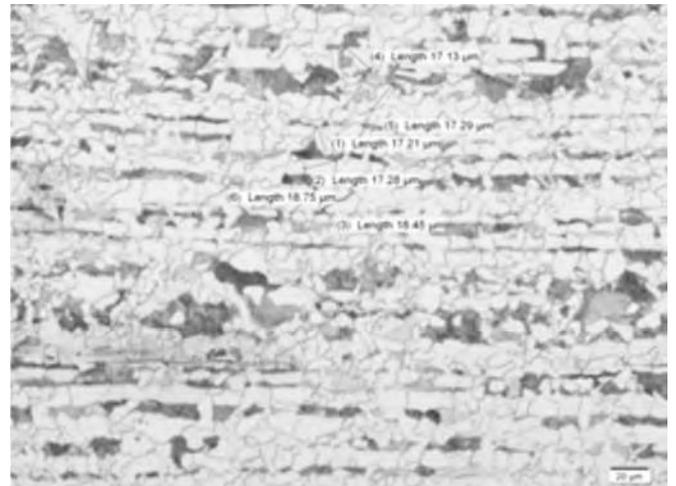
Figure 6: Parent material microstructure

The microstructure of the parent material as obtained from one of the specimens is shown in Figure 6.

Figure 6 also shows the grain morphology resulting from the plate rolling process and the grain sizes. Figure 7 is a low magnification image showing the general extent of the HAZ.
