Investigating Structural Cracks for Infrastructure: Case Study of Anonymous Hospital, in Zimbabwe

Faculty of Engineering, University of Zimbabwe, P.O Box MP167 Mount Pleasant, Harare, Zimbabwe

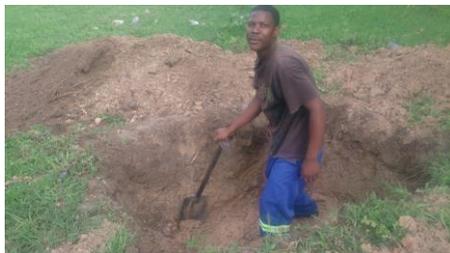
Fig. 4. Digging trial pits for geotechnical tests.

and the task included excavation of trial test pits, collecting soil samples, conducting in-situ tests such as the direct cone penetrometer test (dcp) and conducting laboratory tests on the samples collected. Figure 4 shows excavation of the trial pit.
